ADDENDUM NO. 1

PROJECT: Makoshika State Park Switchback Road Repair

Final Geotechnical Engineering Report

Makoshika State Park Road Stabilization

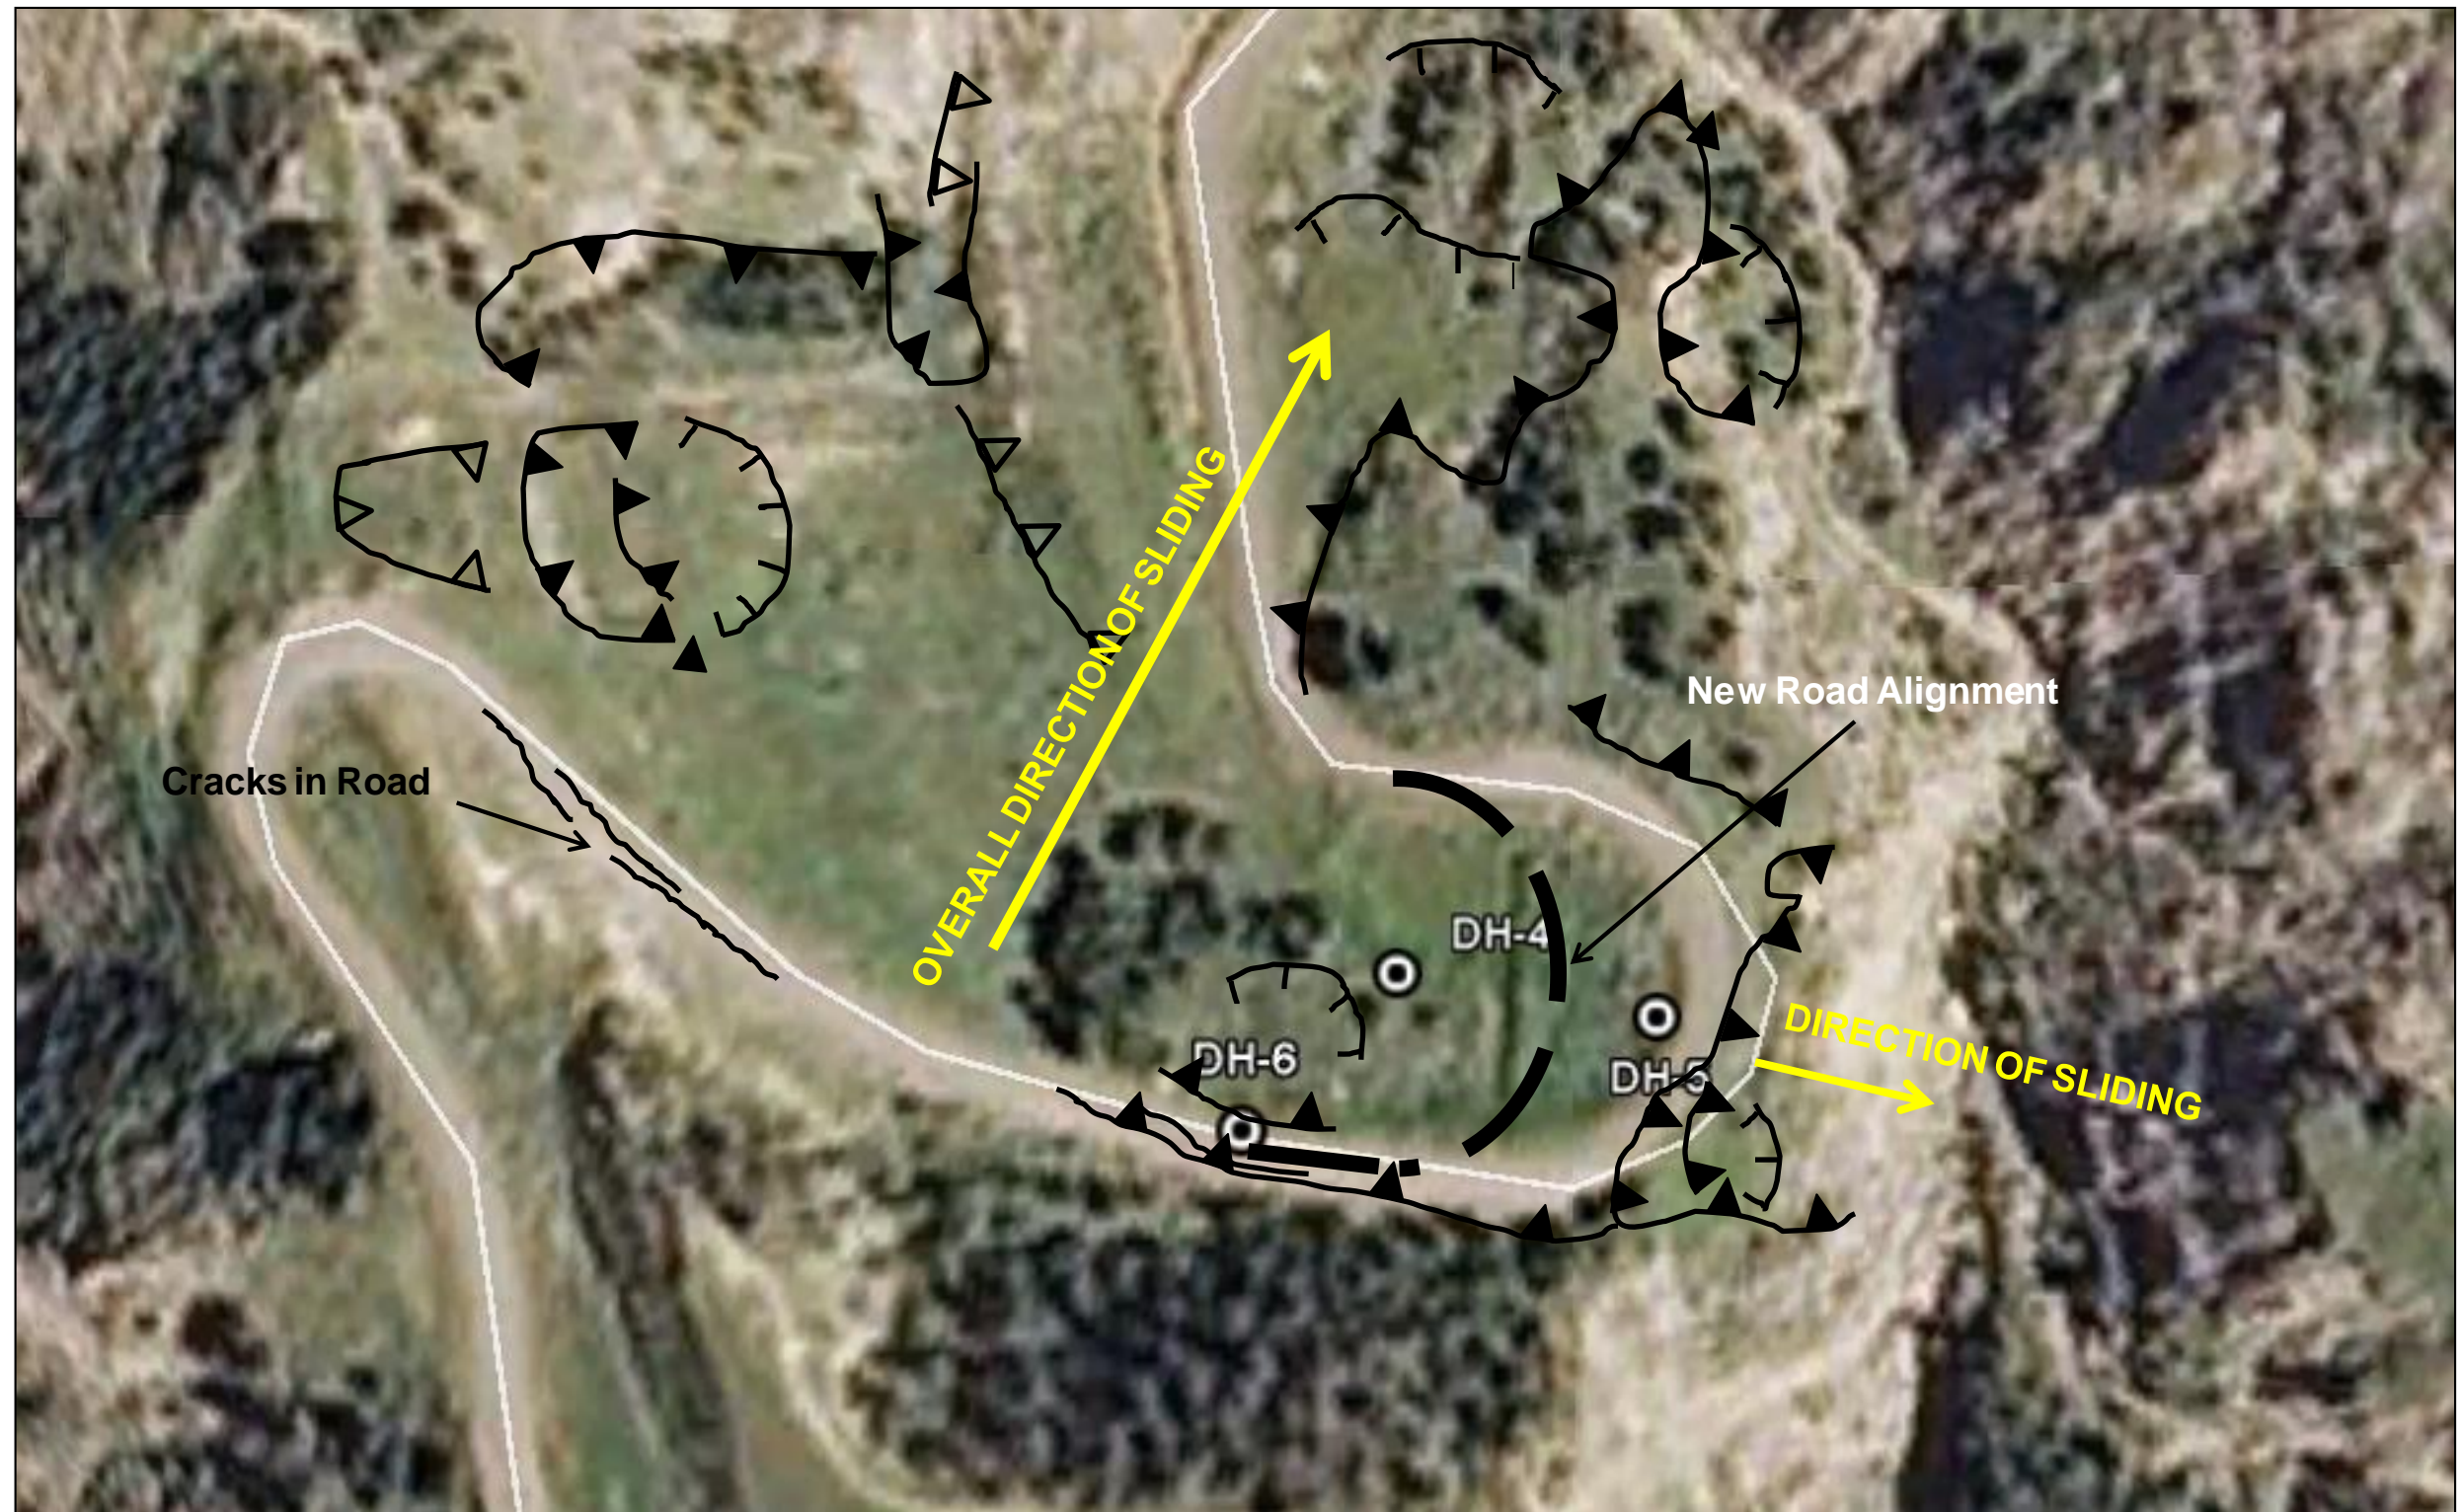
Approximate Boring Location
 Active Scarp
 Inactive/Dormant Appearing Scarp

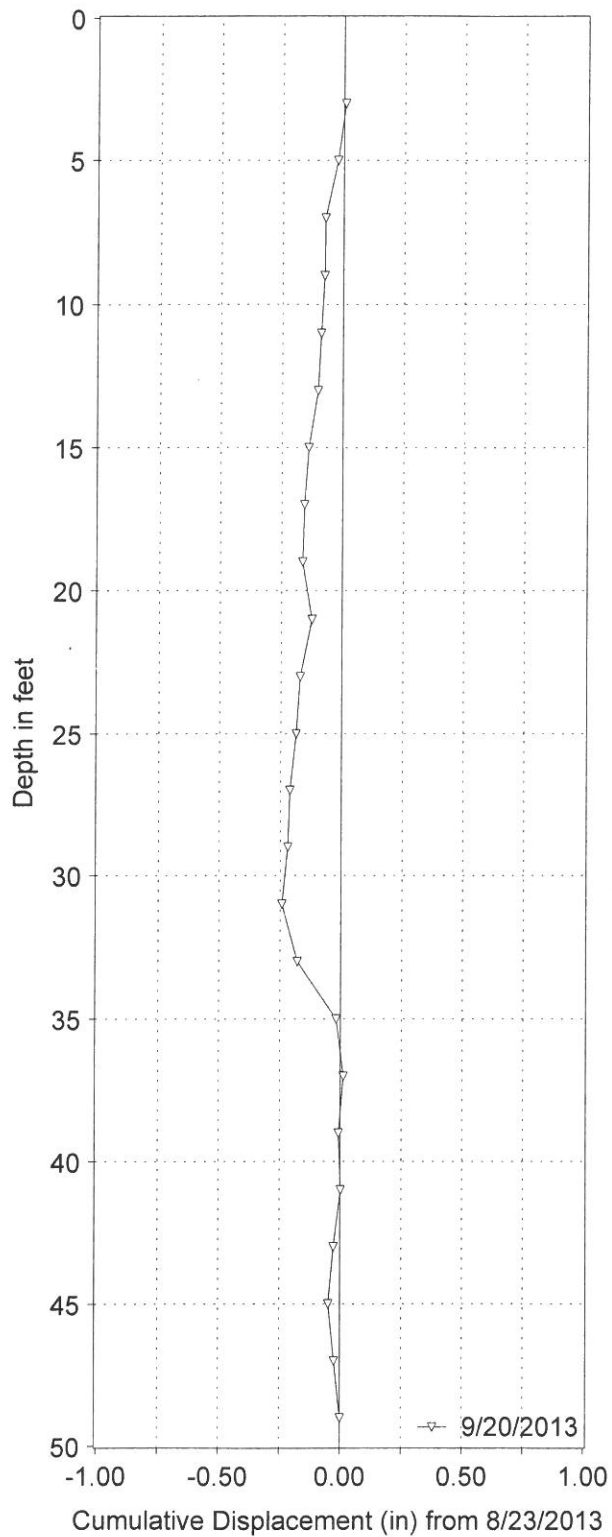
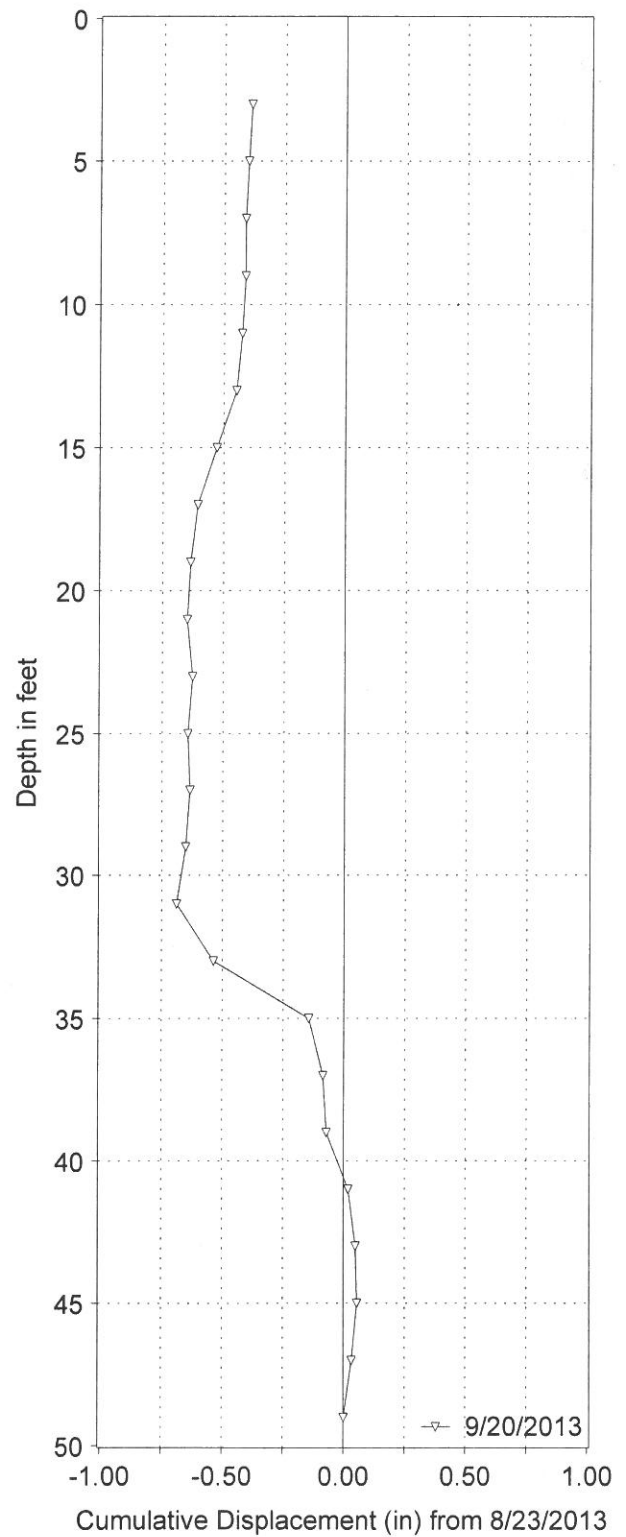
MIKOSH DH_5, A-Axis

Initial readings for the inclinometers were recorded at the time of drilling, and comparative readings were taken subsequently on September 20, 2013 with results depicted in profile on the attached Inclinator Summary sheets included in Appendix A as Exhibits A-6 and A-7. Deflections of the casing are plotted relative to the initial, normalized vertical “0” displacement line. The A-axis is oriented in the “Direction of Sliding” noted on the Site Plan, while the B-axis is in the perpendicular direction. The readings for DH-5 in the vicinity of the 2011 slide show movements of 0.5 to 0.75-inch at or near the shale surface running in the transverse or B-axis direction; this is interpreted as indicating movement mostly governed by the tendency of the mass at large to move in the northeasterly direction. The readings for DH-6 show two movement zones, one near the shale contact and another higher zone at approximately mid-
